Green Roof Performance Study

Seattle Public Utilities

June 2012

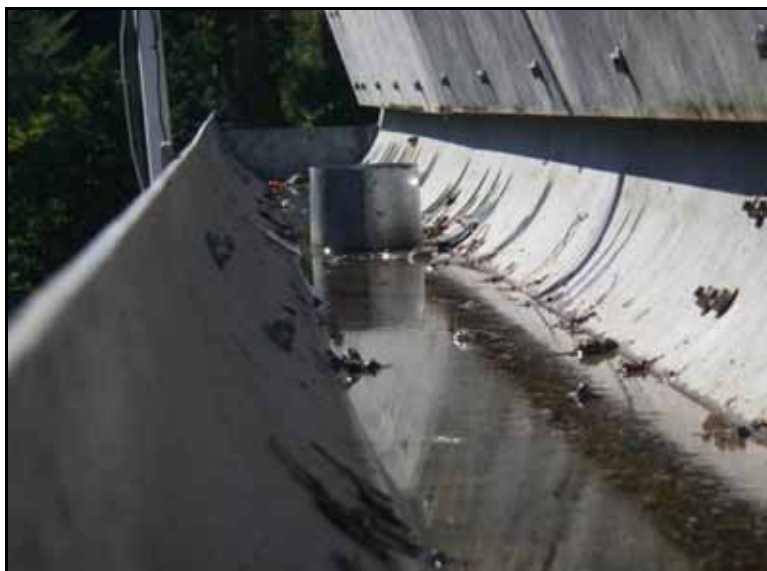
Figure 2-2 Downspout Risers Installed in the Roof Gutter

Weather and flow measurements were collected and averaged over a five minute period, then stored to the memory of the corresponding datalogger. Access to the Zoo network was arranged so that data could be downloaded with a simple Ethernet connection; however, due to security firewall complications data was later collected by manual download. Raw data was backed up to an analog tape and kept as a physical backup at the Cardno TEC office. To save on equipment costs and improve data quality, the three existing gutter drains were consolidated into a drain in the center. Cardno TEC worked with the Zoomazium architect, Mithūn, and determined that the runoff from the entire roof could be directed into the center downspout. Riser pipes (Figure 2-2) were installed in the remaining drains allowing them to bypass, should the system become blocked.

Soil depth, soil composition and vegetation for the Zoomazium green roof are provided in Table 2-1 and the implementation plan (Appendix A). It should also be noted that all green roof runoff is captured and conveyed off the green roof via one galvanized gutter. This gutter runs the length of the roof's eastern edge (Figure 2-1 and Figure 2-2).

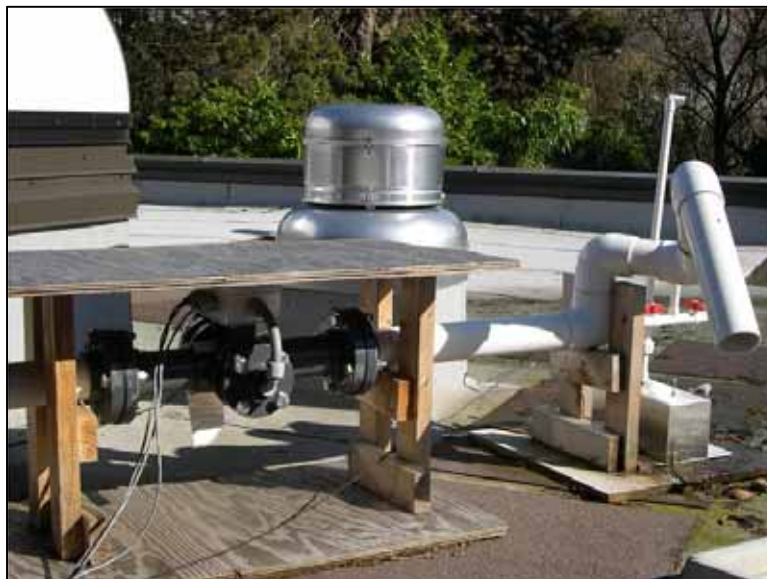
Figure 2-3 Three Inch Unimag DP03ECTERPAA Dual Sensor Electromagnetic Flow Meter

The magmeter (Figure 2-3) installed to measure higher flow rates has diminishing accuracy as flow rates drop beneath 1.5 gallons per minute (gpm) which is why a tipping bucket (Figure 2-4) was added to the monitoring system. The tipping bucket is designed by the manufacturer to measure flow rates up to 2.0 gpm. However, prior to installation while testing and calibrating the instrument, Cardno TEC staff noted the tipping bucket did not tip at the expected rate as the flow approached 2.0 gpm. A decision was made to develop a calibration curve by recording the number of tips per minute at several different flow rates. This allowed for the development of a tips/minute to flow rate relationship. The tipping bucket calibration curve developed by Cardno TEC is included in the implementation plan (Appendix A). The installed monitoring station measured runoff as it passed through the magmeter, into the tipping bucket and onto the conventional roof.

Initially, it proved problematic to accurately monitor the full range of flows from the Zoomazium green roof. Thus, a two-stage flow monitoring system was designed to accurately measure the wide range of flow rates that was estimated to runoff. Two designs were considered for the flow monitoring system. The first design included a HS Flume and tipping bucket combination, but required extensive roof modification. The second design included a tipping bucket flow meter and electromagnetic flow meter to measure the higher flows. Both design options had comparable capabilities, however, installation of a flume would have required modifications to the roof and subsequent increased monitoring costs.

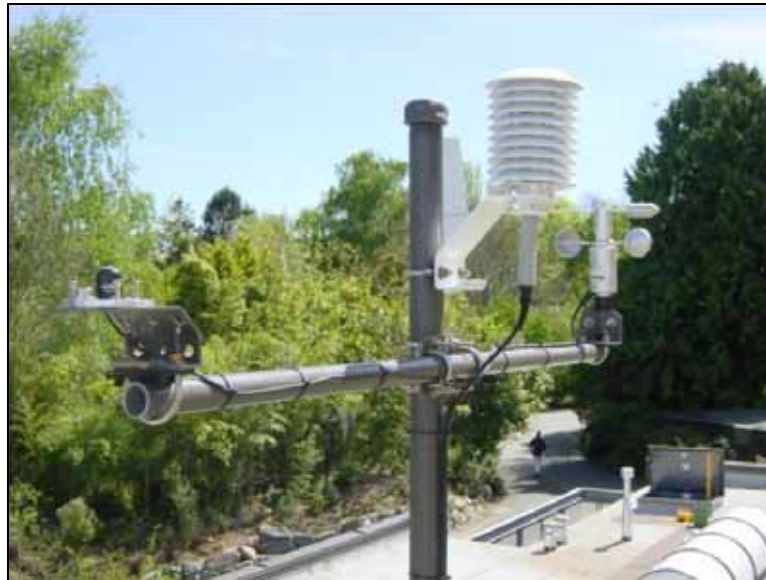
Figure 2-5 Weather Station Containing Wind Speed, Air Temperature, Relative Humidity and Solar Radiation Sensors

A weather station that monitors wind speed, air temperature, relative humidity, and solar radiation was installed on the Zoomazium roof. The data collected, which are assumed to represent hydrologic input (rainfall) and output (evapotranspiration) conditions on the green roof, provide a basis for calibrating these processes within the hydrologic model. Each sensor was mounted to a mast secured to a center roof beam above the flow monitoring station (Figure 2-5). A rain gauge was placed on the conventional roof in a location that minimized interference from nearby trees or the elevated green roof. It was mounted to a plywood platform that both anchored and allowed it to be leveled during maintenance visits. Rain gauge tips were individually recorded by a datalogger and stored to memory. The rain and irrigation totals were used to calculate all moisture inputs to the green roof. Wires from each sensor were connected to the corresponding datalogger. Any unintentional effects from maintenance (that is, false rain gauge tips) were noted on the field sheet and later removed or corrected from the dataset.

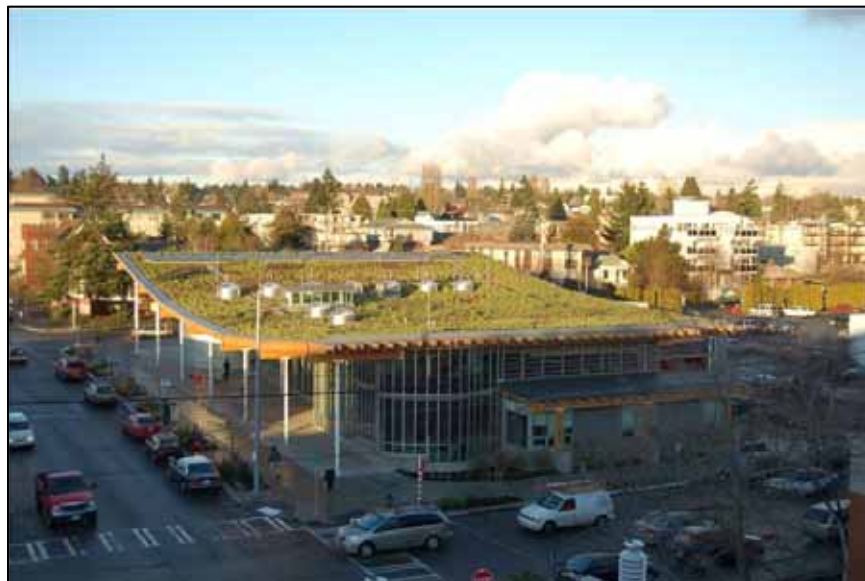
Figure 2-6 Green Roof on the Seattle Public Library Ballard Branch

The Seattle Public Libraries' Ballard Branch (Figure 2-6) was the second roof to come on-line for the study and is located in Seattle's Ballard neighborhood at 5614 22nd Avenue Northwest. The library opened May 14, 2005, as part of the "Libraries for All" building program and was designed by Bohlin Cywinski Jackson and built by PCL Construction Services, Inc. Approximately 18,000 plants were used on the Ballard Library green roof, which covers approximately 20,000 sf. Three pairs of downspouts located in the center of the concave roof, capture runoff and redirect it to the combined sewer system. Solar panels were installed on the northern edge of the roof taking advantage of an unobstructed southern exposure. Monitoring for the Ballard Library green roof was initiated in May 2007 and completed in June 2008.

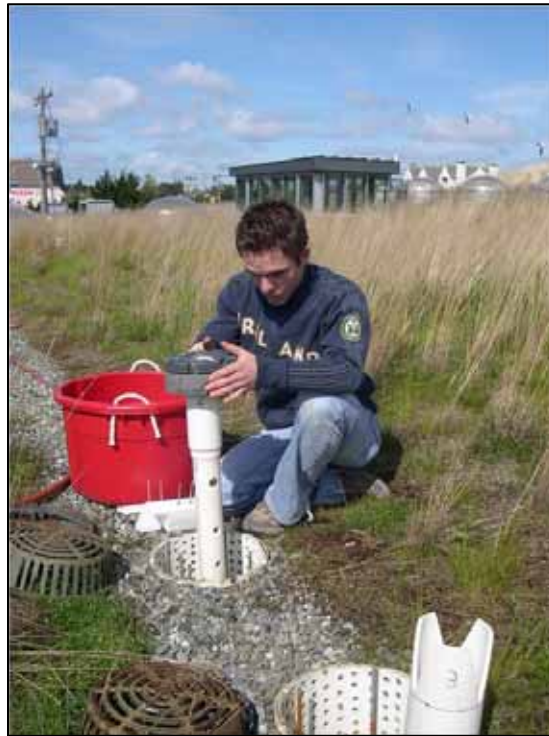
Figure 2-7 Installation of the Primary Flow Device in the Roof Drain

The bypass insert was constructed of PVC and to maintain drain capacity (in case of severe rain or a plugged primary drain) had a slightly larger diameter than the drain pipe. Three V-notch weirs were cut into a four-inch PVC pipe (Figure 2-8) to create a consistent flow control surface. Pressure transducers were then installed within the primary drain and behind the bypass inserts and calibrated to measure water level at the invert of the lowest orifice and v-notch weir.

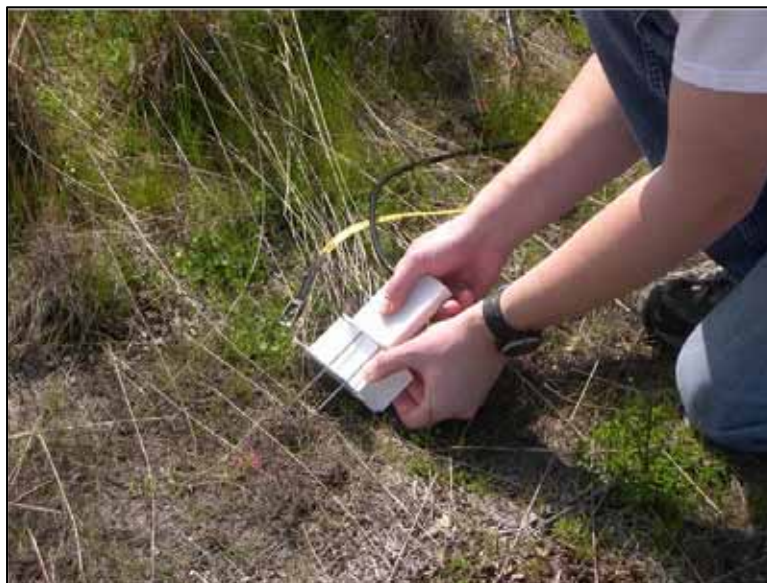
Figure 2-9 Installation of Soil Moisture Content Probe

Soil moisture data were collected as supplemental measurements. Four soil moisture sensors were installed on the green roof in a line running north-south to represent the varying roof slope and aspect. The two metal electrodes on the probe were inserted on an angle and with care to not puncture the roof membrane (Figure 2-9). Communication wires from the sensing bodies were run underneath the soil media surface and hardwired to the datalogger. Specifications for all sensors are in the implementation plan (Appendix A).

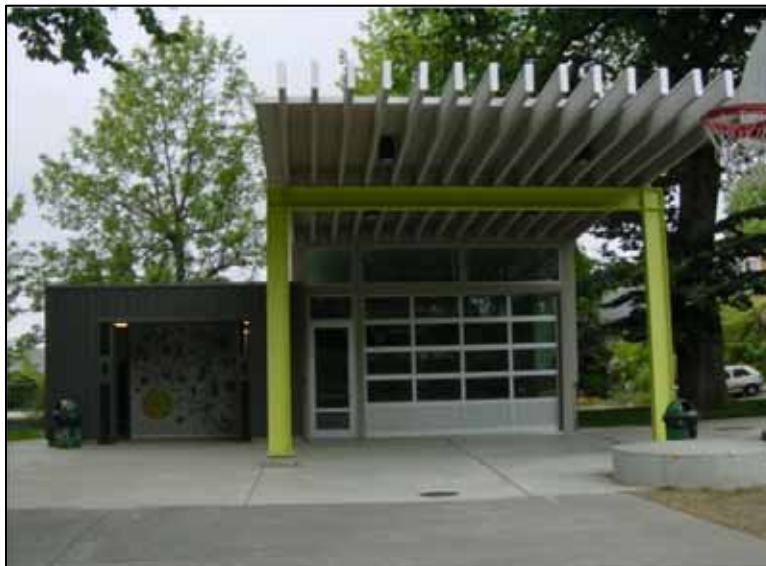
Figure 2-10 Shelterhouse at the Ross Playground

The Ross Park Shelterhouse (Figure 2-10) was the third building to come on-line for the GRPS. The building is situated in the northwest corner of the Ross Playground at 4320 4th Avenue

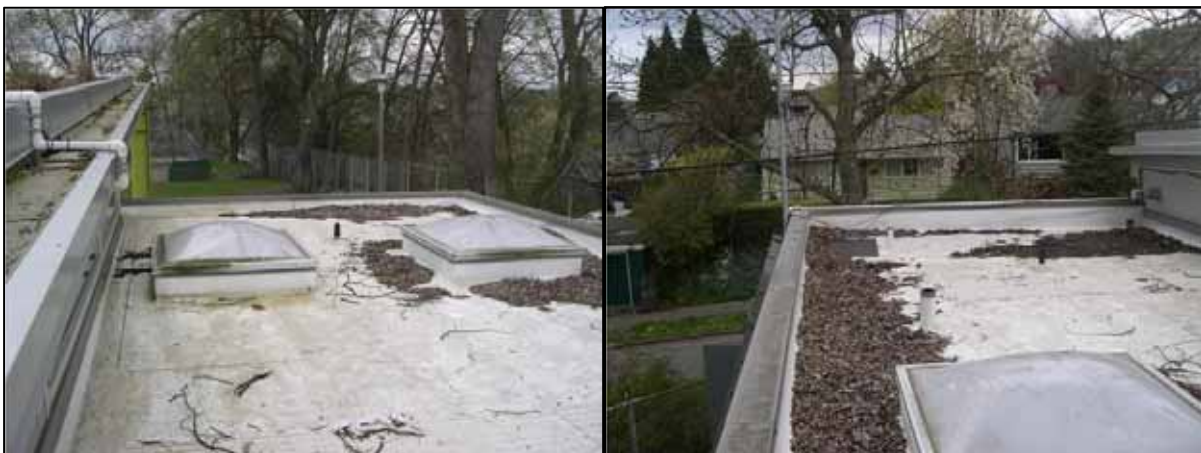
Figure 2-11 Conventional Roof Located on the West Roof of the Shelterhouse

The Ross Park Shelterhouse has two separate roof sections that are parallel but at different elevations. The conventional roof (Figure 2-11) is 470 sf of flat membrane that drains to a pair of scuppers on the north side of the building. It covers the public bathrooms and is lower in elevation than the green roof by approximately five feet. The green roof (Figure 2-12) covers the eastern public use portion of the building and is approximately 876 sf. Runoff is collected in a pair of slotted drains on the north end of the green roof, where a drain pipe conveys roof runoff to the monitoring station. Soil and vegetation characteristics for the green roof are listed in the implementation plan (Appendix A) and in Table 2-1. Data collection for the Ross Park site was initiated on October 1, 2007, and continued for 12 months ending on September 20, 2008.

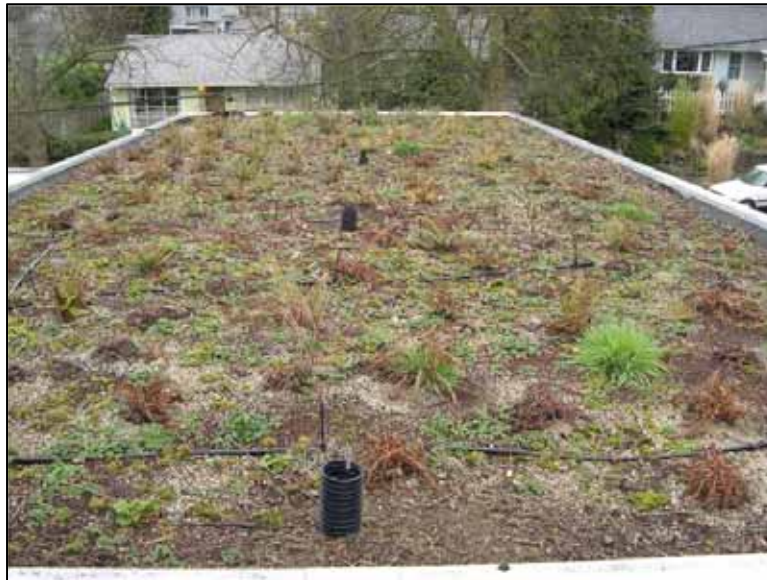
Figure 2-12 Green Roof located on the East Roof of the Shelterhouse

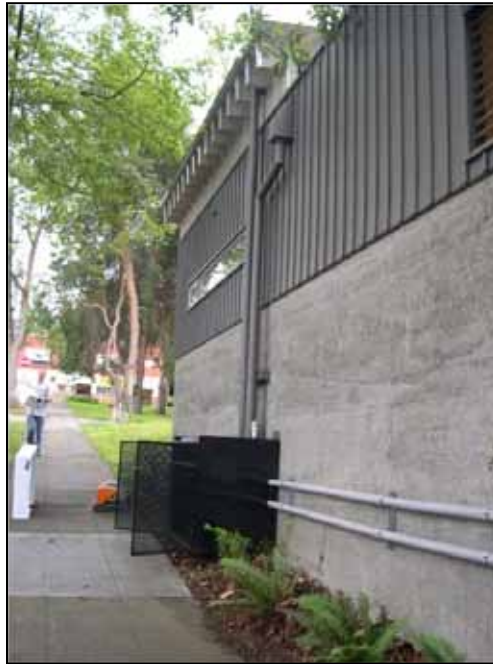
Figure 2-13 Photo Ross Park Shelterhouse Flow Monitoring Box, Located on the North Side of the Building

Per the manufacturer, the tipping bucket was designed to accurately measure flow rates up to 2.0 gpm; however, the same variance in accuracy at the upper design rate was found. Cardno TEC developed a rating curve by recording the number of tips per minute at several flow rates to develop a rating curve based on the observed tips-per-minute to flow rate relationship. The

tipping bucket rating curve can be found in the implementation plan (Appendix A). To protect the pressure transducer during periods of sustained freezing temperatures, heating elements were placed in the flume sumps. The heating elements were turned on prior to a predicted period of freezing temperatures and then turned off when temperatures rose above freezing.

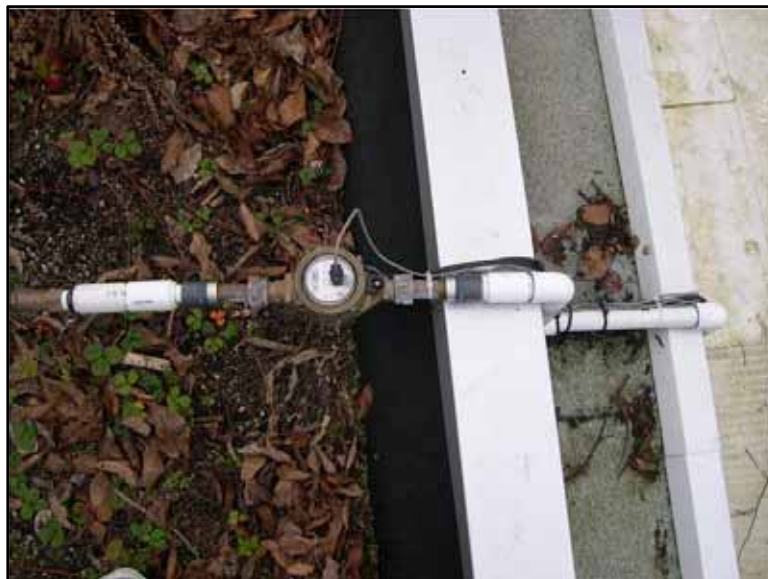
Figure 2-15 Multijet Meter Installed for Measurement of Irrigation Water Delivered to the Ross Park Shelterhouse green roof

Moisture inputs from irrigation were measured with a Multijet turbine flow meter (Figure 2-15). Every gallon applied to the roof triggered an electrical pulse that was recorded by the datalogger. The meter was installed on the green roof upstream of the drip lines and typically only recorded flow during the dry season. During extended periods of freezing, it was necessary to bleed the lines so that the flow meters internal components were not damaged.

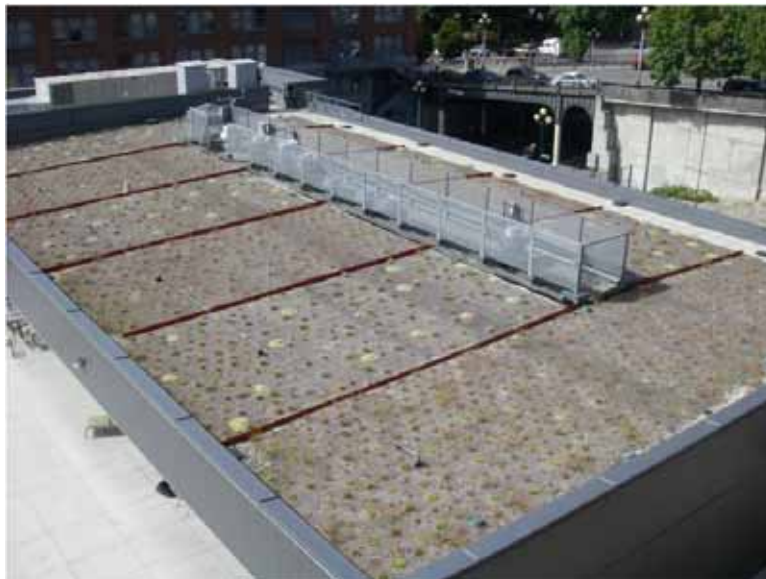
Figure 2-16 View of the Fire Station 10 Green Roof from the Emergency Operations Center Rooftop

The EOC green roof is located to the east of and two stories higher in elevation than the FS10 green roof (Figure 2-16). The EOC green roof slopes to the west except for a small southern portion that slopes eastward. Soil and vegetation characteristic for this green roof can be found in the implementation plan (Appendix A). The monitored portion of the conventional roof is a membrane covered in ballast and is located on the north end of the EOC building. Data collection for all three roofs at the FS10/EOC complex was initiated on April 18, 2008 and continued through June 30, 2011.

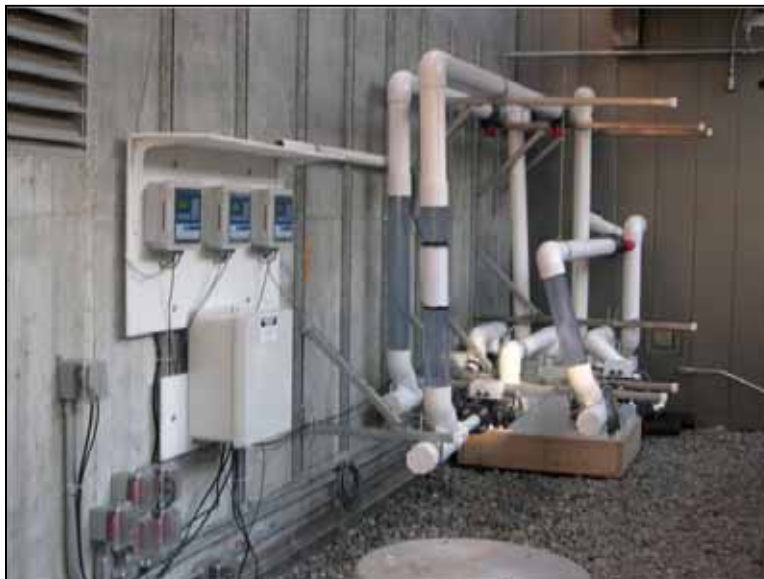
**Figure 2-17 FS10 / EOC Flow Monitoring Station
Located on the West Side of the EOC Building**

The flow monitoring station was located on northwest exterior wall of the second story of the EOC building, adjacent to the diesel generator. Runoff from the three roofs was collected in slotted drains and routed to individual rain leader pipes. Rainwater drains were deliberately plumbed to keep roof runoff isolated until it reached the monitoring station. At which point the three pipes (one from each roof) run in parallel through three independent monitoring systems. Runoff from each roof flows through a 2" Unimag magmeter to a Unidata tipping bucket (Figure 2-17). Runoff from both green roofs was captured in a HDPE tank, which recombined green roof runoff into a single rain water leader pipe. Conventional roof runoff was drained separately. Each of the three pipes had a bypass at the upstream end of the monitoring station that discharged to the plastic tank. Should a clog or malfunction occur, all flow was diverted around the monitoring equipment and into the tank.

The two-stage flow monitoring system allowed for accurate measurement of both low and high flows from the green and conventional roofs. Lower flow rates (less than 1.8 gpm) were measured by the tipping bucket while the magmeter measured flows from 1.8 gpm to a maximum rate of 160 gpm. Consistent with other monitored sites, initial bench testing found

that the tipping bucket manufacturer's estimated range was inaccurate. The new curves were developed based on an observed tips-per-minute to flow rate relationship. The tipping bucket rating curves developed by Cardno TEC are included in the implementation plan (Appendix A).

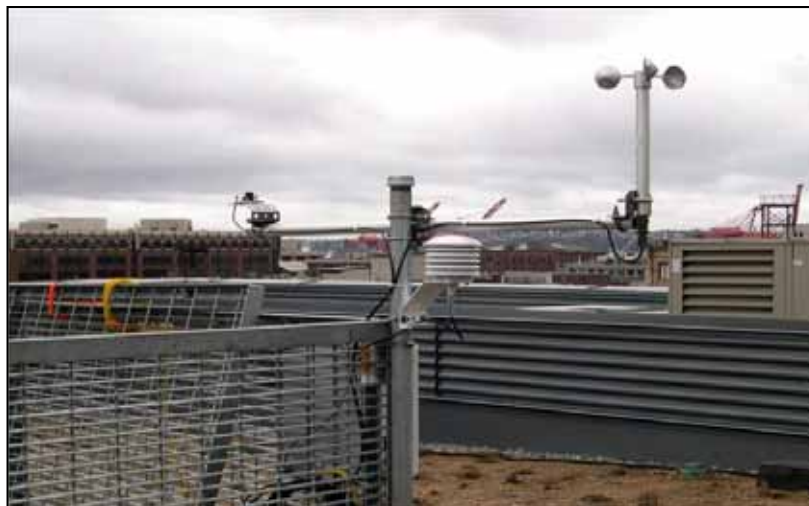
Figure 2-18 Meteorological Sensors (Weather Station) Installed on the FS10 Green Roof

A weather station that monitored wind speed, air temperature, relative humidity, solar radiation, and precipitation was installed on the FS10 green roof. Meteorological data represents specific weather conditions for this site and are not intended to represent weather conditions beyond the FS10/EOC complex. The tipping bucket rain gauge was secured to a platform in the center of the FS10 green roof to minimize the effect of tall structures (Figure 2-18). The remaining sensors were fastened to a mast approximately 6 feet above roof level. The mast was then secured to the corner of the protective metal fencing surrounding roof vents. Precautions were made to keep sensors away from any building vents that may affect temperature or relative humidity measurements.

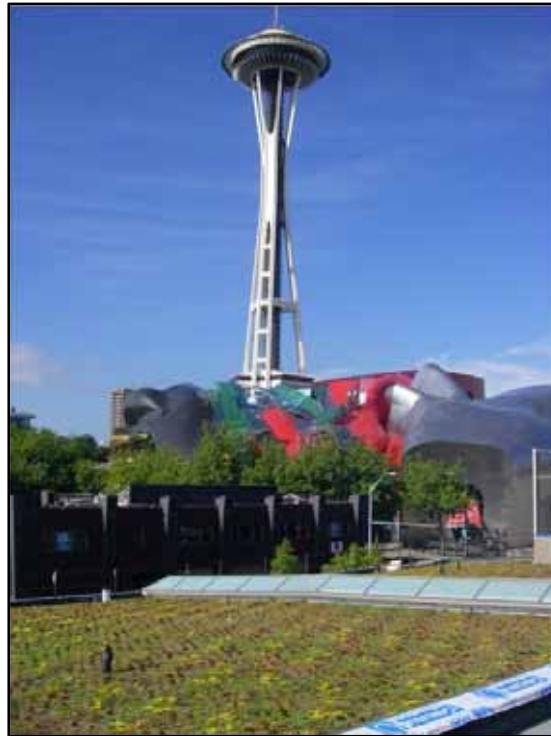
Figure 2-19 Seattle City Center Parking Garage Green Roof

The monitoring effort at the SCPG was completed through the concept design phase; however, due to budget shortfalls the monitoring system design was never finalized nor installed. The SCPG green roof (Figure 2-19) covers nearly 1.5 acres and is located at the intersection of Harrison Street and 5th Avenue North. The structure was built through collaboration between the Bill & Melinda Gates Foundation and the Seattle Center. The parking facility was funded by the Seattle Center with funding for the green roof provided by The Bill & Melinda Gates Foundation. The roof is predominantly north facing with the southern quarter sloping to the south. The green roof design and plantings list can be found in Appendix D. Preliminary designs began in Nov 2007 and ended with partial equipment procurement in December 2008.

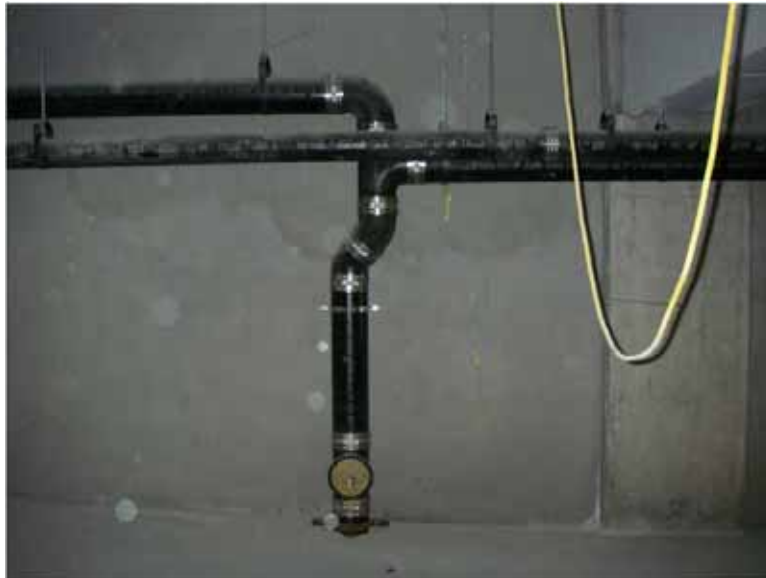
Figure 2-20 Location of the SCPG Main Flow Monitoring Station on Level P2

Each facility presents a unique set of challenges to overcome. In this case it was not feasible to independently monitor runoff from the green roof because the green roof was not isolated from sections of the conventional roof. This required a second location to monitor contributions from a sub-section of the conventional roof. Measured flow rates from the conventional roof sub-section would then be used to model total contributions from the conventional roof. The conventional roof runoff total could then be subtracted from the total (green + conventional) runoff measured. The main flow monitoring station was designed to be installed on Level P2 against the east wall (Figure 2-20). The main station monitored flow in three stages; including a tipping bucket flow meter and two mag-meters. Runoff would pass through a 6-inch magmeter, a 2-inch magmeter and a tipping bucket flow meter (Appendices C and D). The combination of the three devices can measure rates from 0 to 1200 gpm, which is the max calculated flow rate for a 2-inch per hour storm.

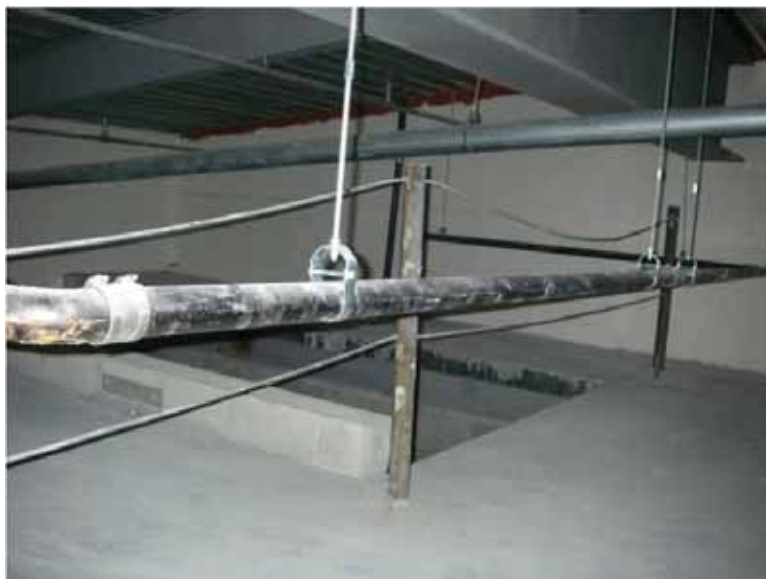
Figure 2-21 Second SCPG Flow Monitoring Location

The second flow monitoring system (Figure 2-21) would measure flow from a sub-section of the conventional roof. A “transition time” flow meter was to be clamped to the outside of a 1-inch PVC pipe on Level P2 near column C12. An output wire from the flow meter would connect directly to a datalogger. The datalogger would then record flow and communicate with the main flow monitoring station through a wireless spread spectrum modem.

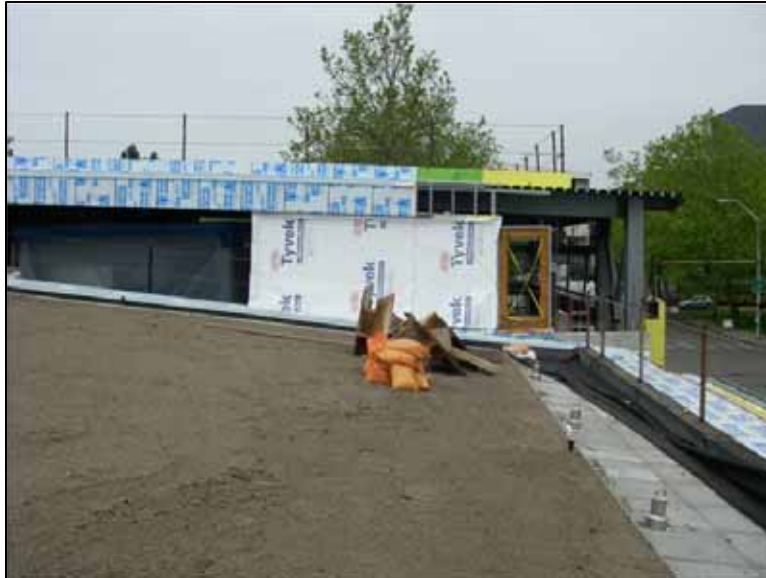
Figure 2-22 Suggested Location of the SCPG Telemetry Enclosure
